Fatigue

Wire Rope Works, Inc.

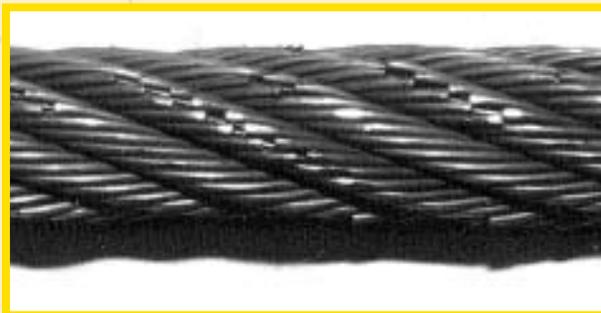
Figure 1: Crown Fatigue Breaks

All wire ropes are subject to fatigue, though the nature and severity of fatigue varies with each application and machine type. Fatigue may be accelerated by abrasion, nicking and other types of damage such as kinking. When fatigue breaks occur and there is no sign of wear, as shown in **Figure 1**, it is usually caused by bending stresses, or those stresses placed on the rope wires while bending under load over a sheave.

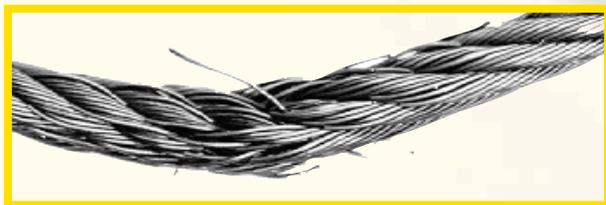
Figure 4: This 6-strand rope, showing extreme fatigue, operated in a reverse bend configuration. Note the number of crown and valley breaks.

From a wire rope manufacturer’s point of view, reverse bends should be avoided, yet they do exist. Because of architectural designs e.g. limited space, elevator OEM’s must adapt their elevator systems, usually resulting in machines that are offset from the hoistway. Any reeving arrangement that involves reverse bends (especially where sheaves, or sheaves and drum are spaced closely) causes the rope to operate at a disadvantage and results in greatly reduced rope life (Figure 4). A reverse bend develops

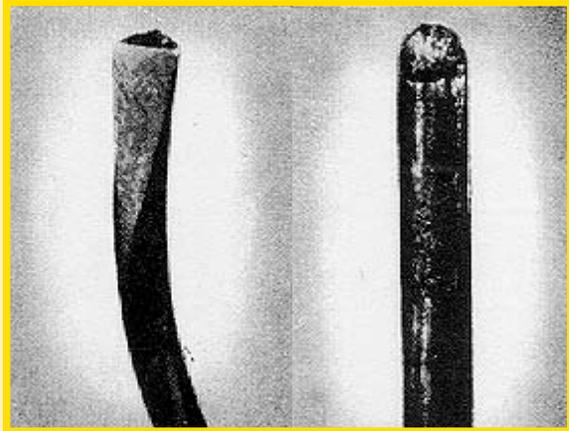
Figure 8: Both photos illustrate fatigue breaks. The fatigue break on the left is caused by abrasion, and is normally found on crown wires. To the right is a true fatigue break typically found to be the cause of valley breaks.

wear, followed by crown fatigue breakage. Though the industry considers these to be true abrasion breaks, they are not. When examined under a microscope, it is clearly evident they are actually fatigue breaks resulting from abrasion, as shown in **Figure 8**. In the event breaks occur on the crown, and little to no surface wear is present, these breaks are true fatigue operating in reverse bend configurations or on sheaves equipped with sheave liners.
